# **Field Report for Airborne Data Collected In Support of US EPA Region 6 Intercontinental Terminals Company LLC Fire 21 March 2019**

## **Data Results Flight 5, 21 March 2019**

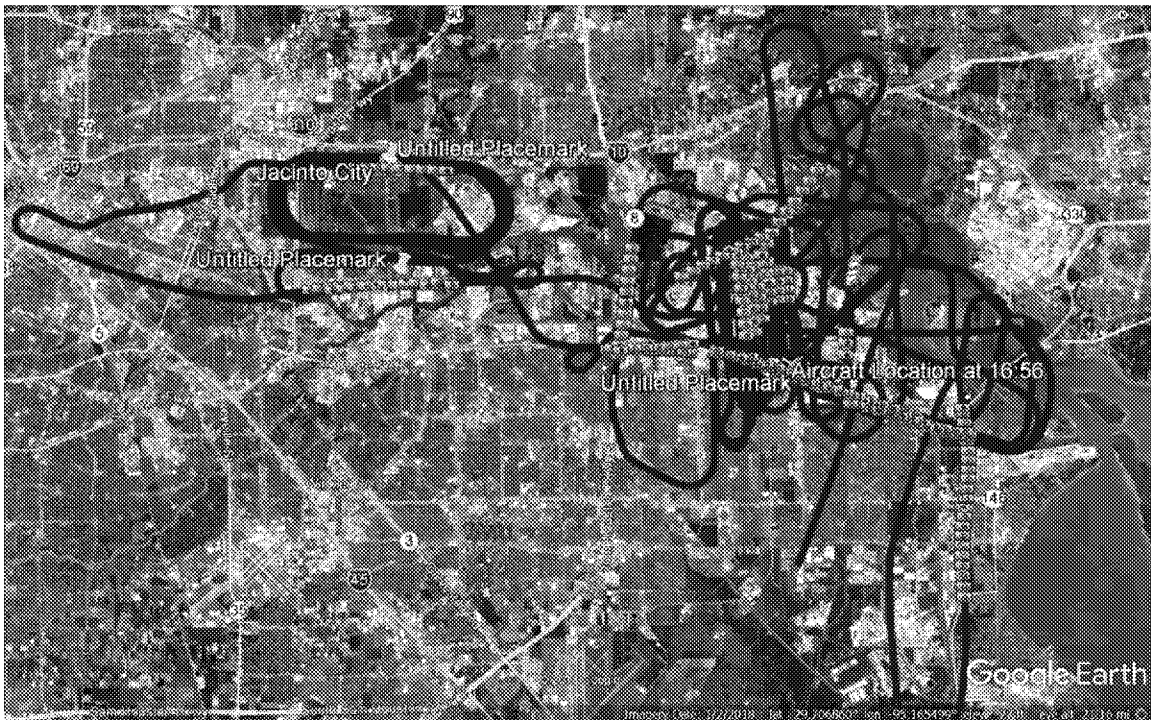
Figure 2: Flight line data for 21 March 2019. The blue lines represent the ASPECT flight path, green lines represent when the Infrared Line Scanner was actively collecting data, and the camera icons represent when a photo was taken.

The order to launch the aircraft was given at 0845 local on 21 March 2019 and the aircraft was airborne at 0900. The initial data collection run over the site was at 0921 (local) and the aircraft made a total of 20 data collection passes; flight information is summarized in Appendix A and Figure 2.

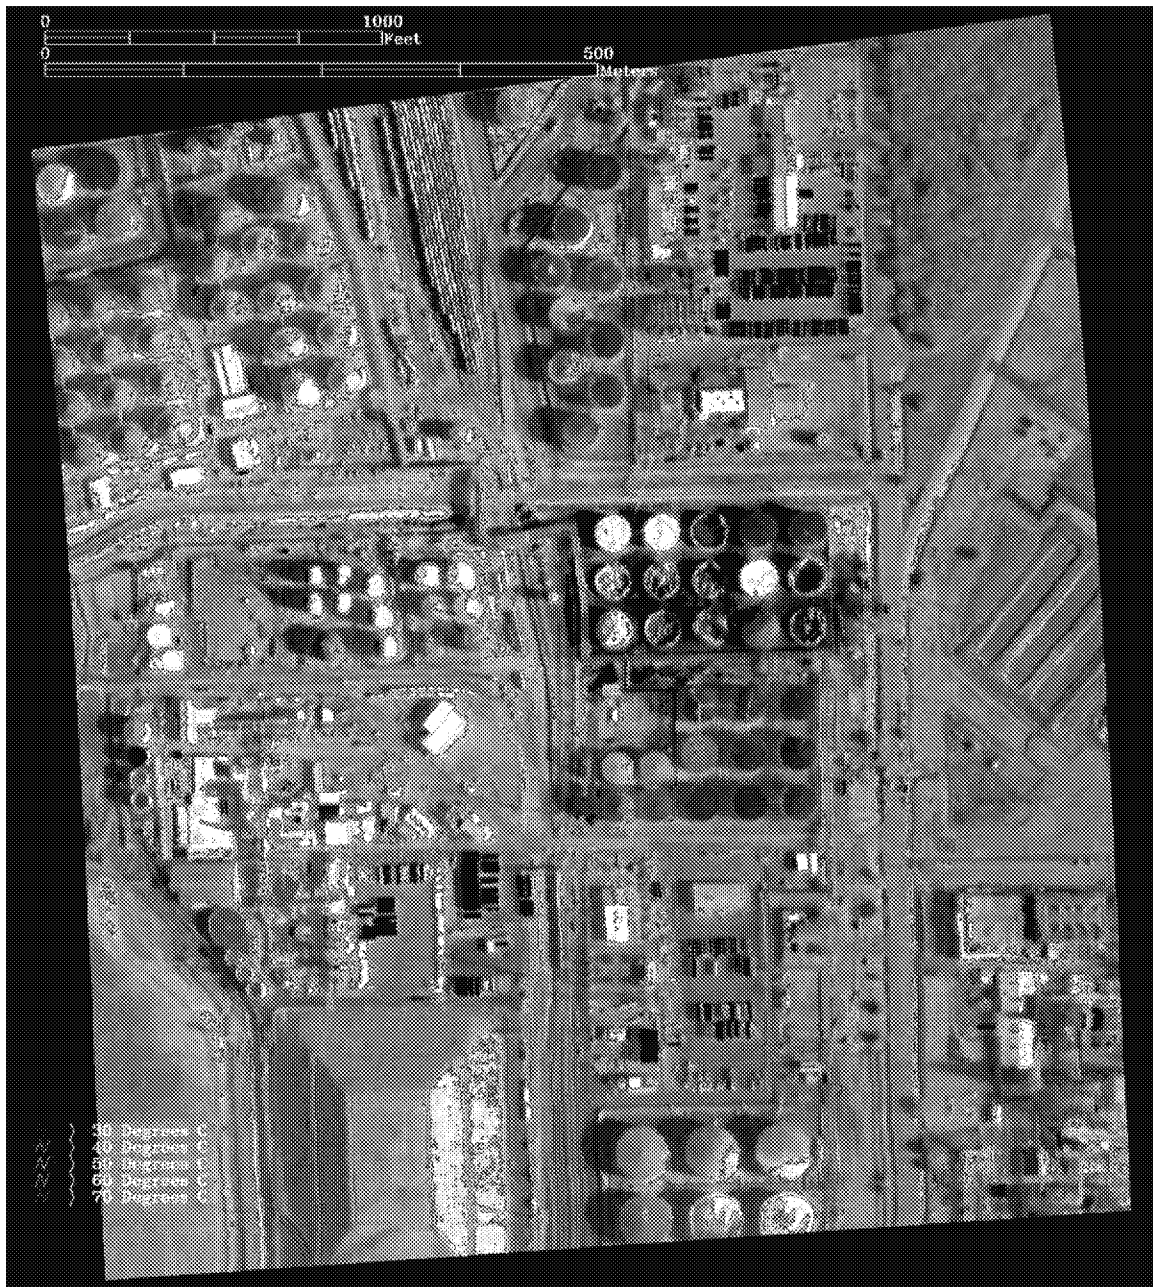
A total of 1 test and 20 data passes were made in the proximity of the impacted tank farm and also in extended areas surround the site and an infrared line scanner images were generated for each pass. Figure 3 shows a typical 3-band infrared image obtained from data collected for Run 5. Examination of the IR image shows a typical industrial scene. Thermal contours are included on the image and show that the tank farm is essentially at approximately 30 °C. It should be noted that process units in the general area are warmer than the tank farm. No plumes were detected in the image.

Figure 3: IR and Thermal analysis of ITC data for 21 March 2019, Run 2

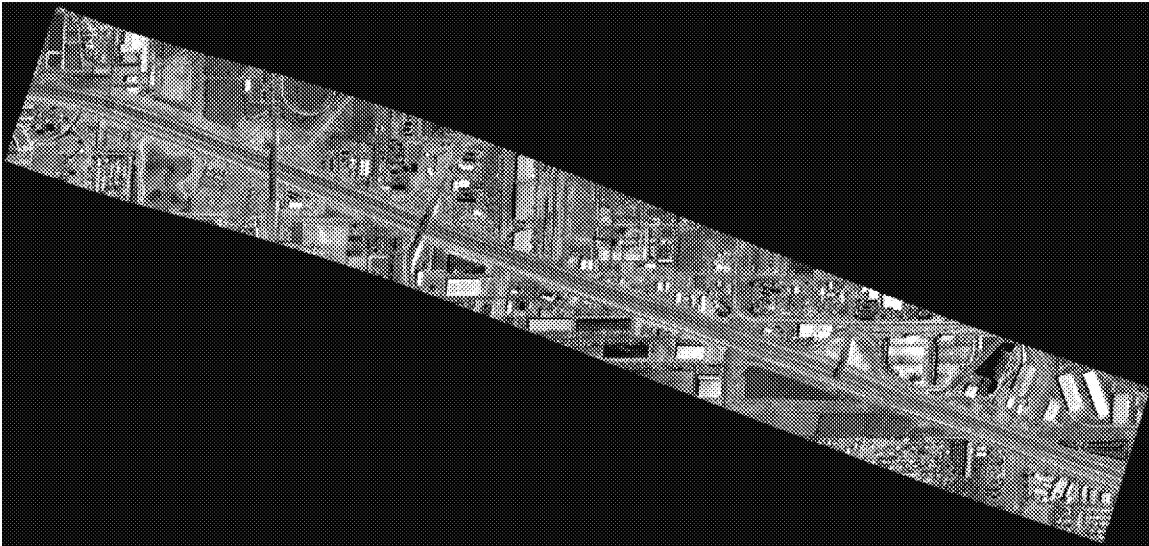
In addition to a focus near the tank farm, ASPECT also conducted a general patrol in extended areas surround Deer Park. Figure 4 is a representative example of a long line scanner collection (Run 11) along highway 225. Analysis of the image showed no unusual signatures.

Figure 4: IR image along highway 225, 21 March 2019, Run 11

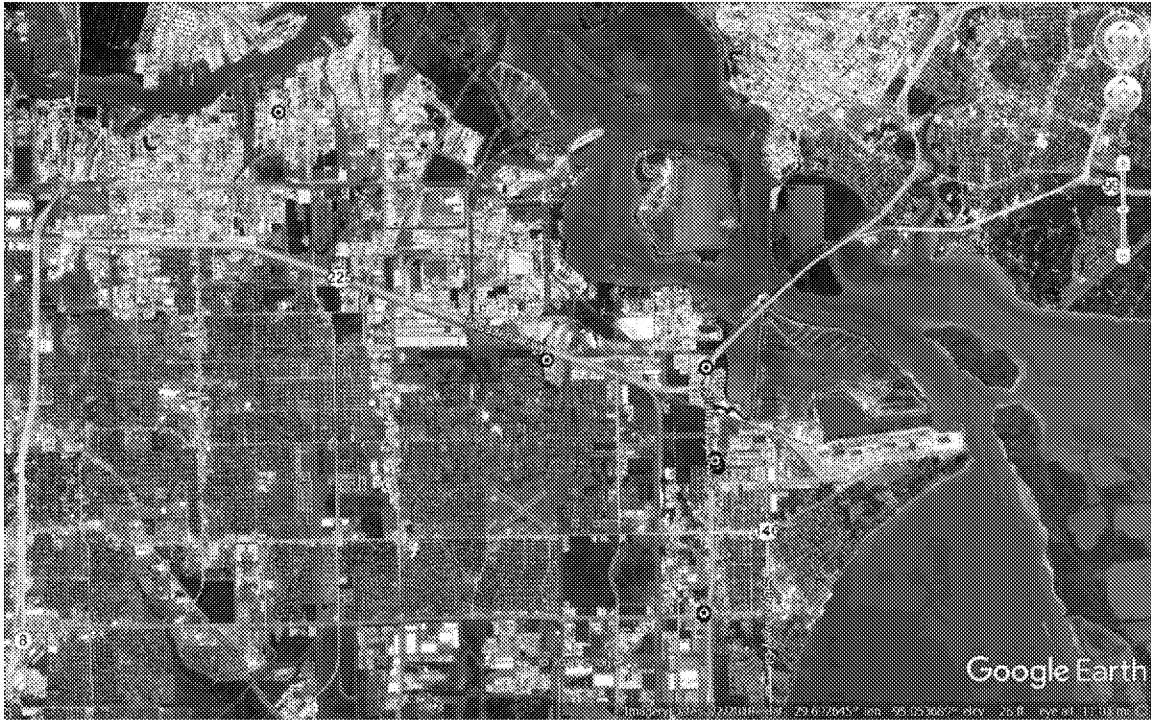
An examination of FTIR data collected on this mission showed low level detections in the general vicinity around the tank farm (Figure 5). These detections included both acetone and isobutylene at levels less than about 1 ppm. Based on the wind direction these detections are likely associated with the normal atmosphere of the urban area.

Figure 5: ITC Fire, Chemical Detection Locations – 20 March 2019

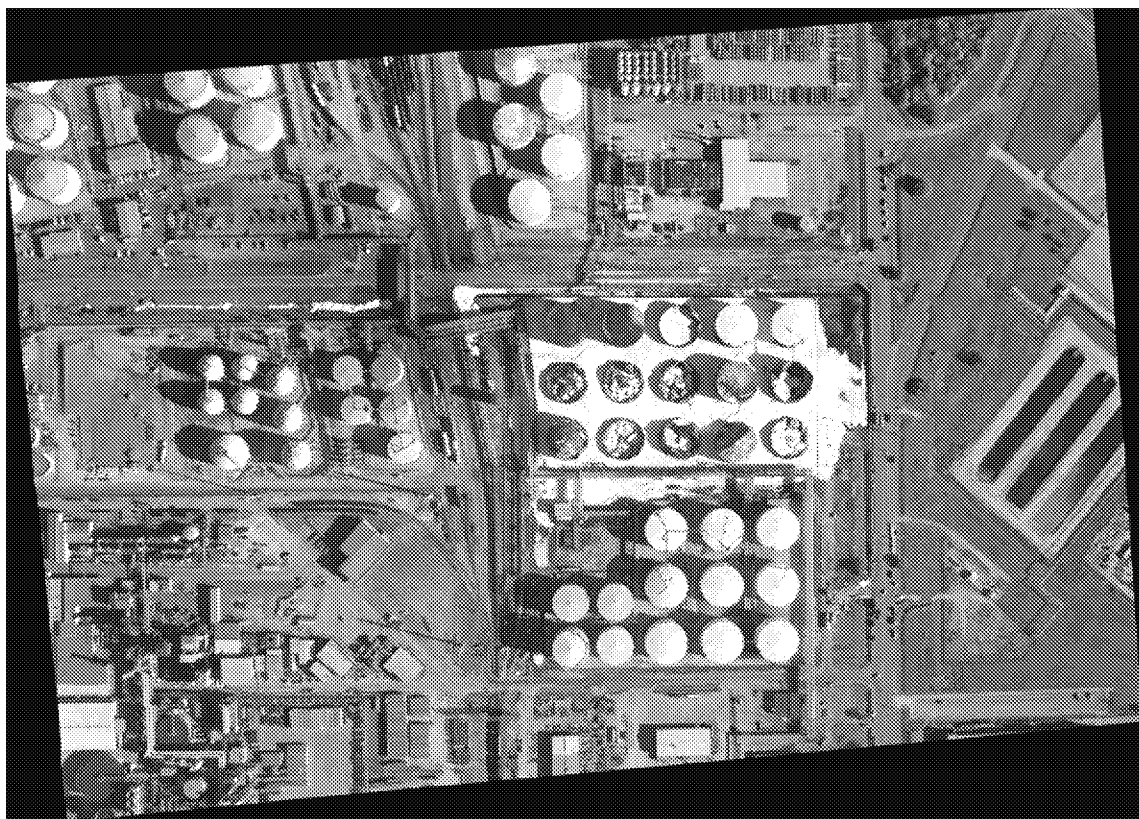
A full set of high resolution aerial digital photography were collected as part of the flight. Figure 6 shows a representative overhead image collected as part of each pass. As evident in the image, the fires associated with the tank farm are absent. In addition, the secondary containment area of the tank farm appears to be filled with a white substance. Figure 7 illustrates a typical oblique image. Both images confirm the finding that the fire has been extinguished and that the secondary containment is filled with a white substance.

Figure 6: Aerial Image of the ITC Tank Farm, Flight 5
